# Wunghnu water tower

## Safety

## Deterioration

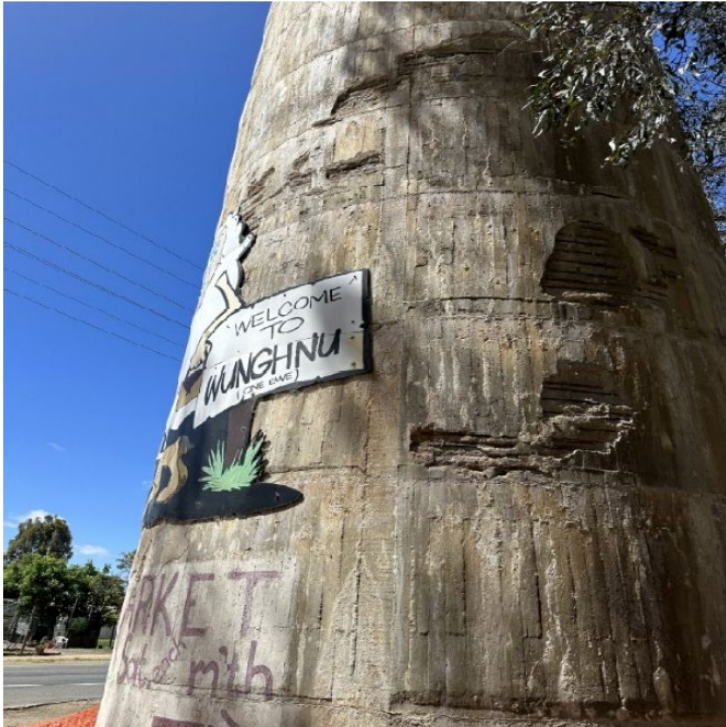
Falling concrete observed at multiple levels all around the tank indicating the corrosion of reinforcement has spread around the tank at all levels.

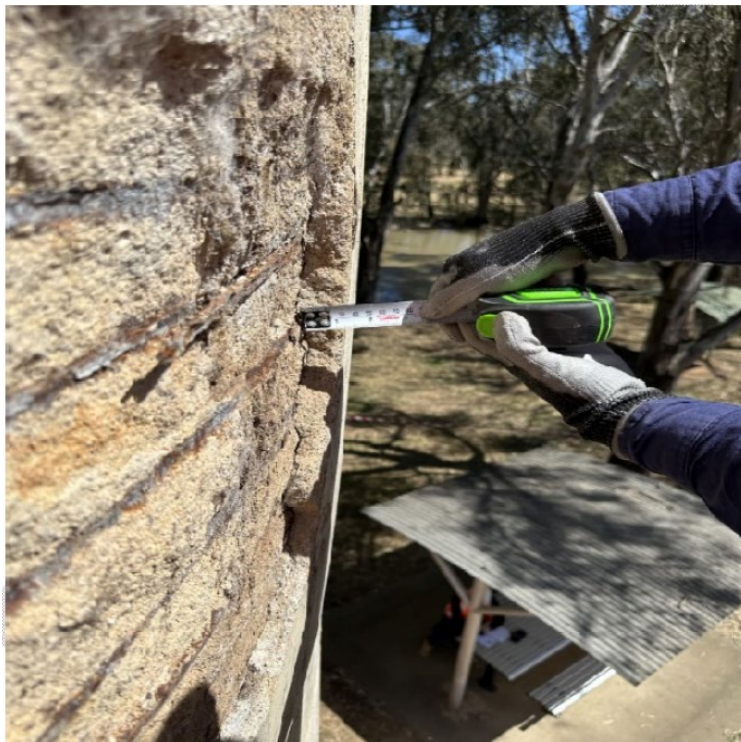
Severe section loss of reinforcement and corrosion forcing the concrete to spall (fall off).
